## CIVIL AERONAUTICS BOARD

**ACCIDENT INVESTIGATION REPORT**

TRANS WORLD AIRLINES, INC., LOCKHEED 1049A, N 6902C, AND  
UNITED AIR LINES, INC., DOUGLAS DC-7, N 6324C,  
GRAND CANYON, ARIZONA, JUNE 30, 1956

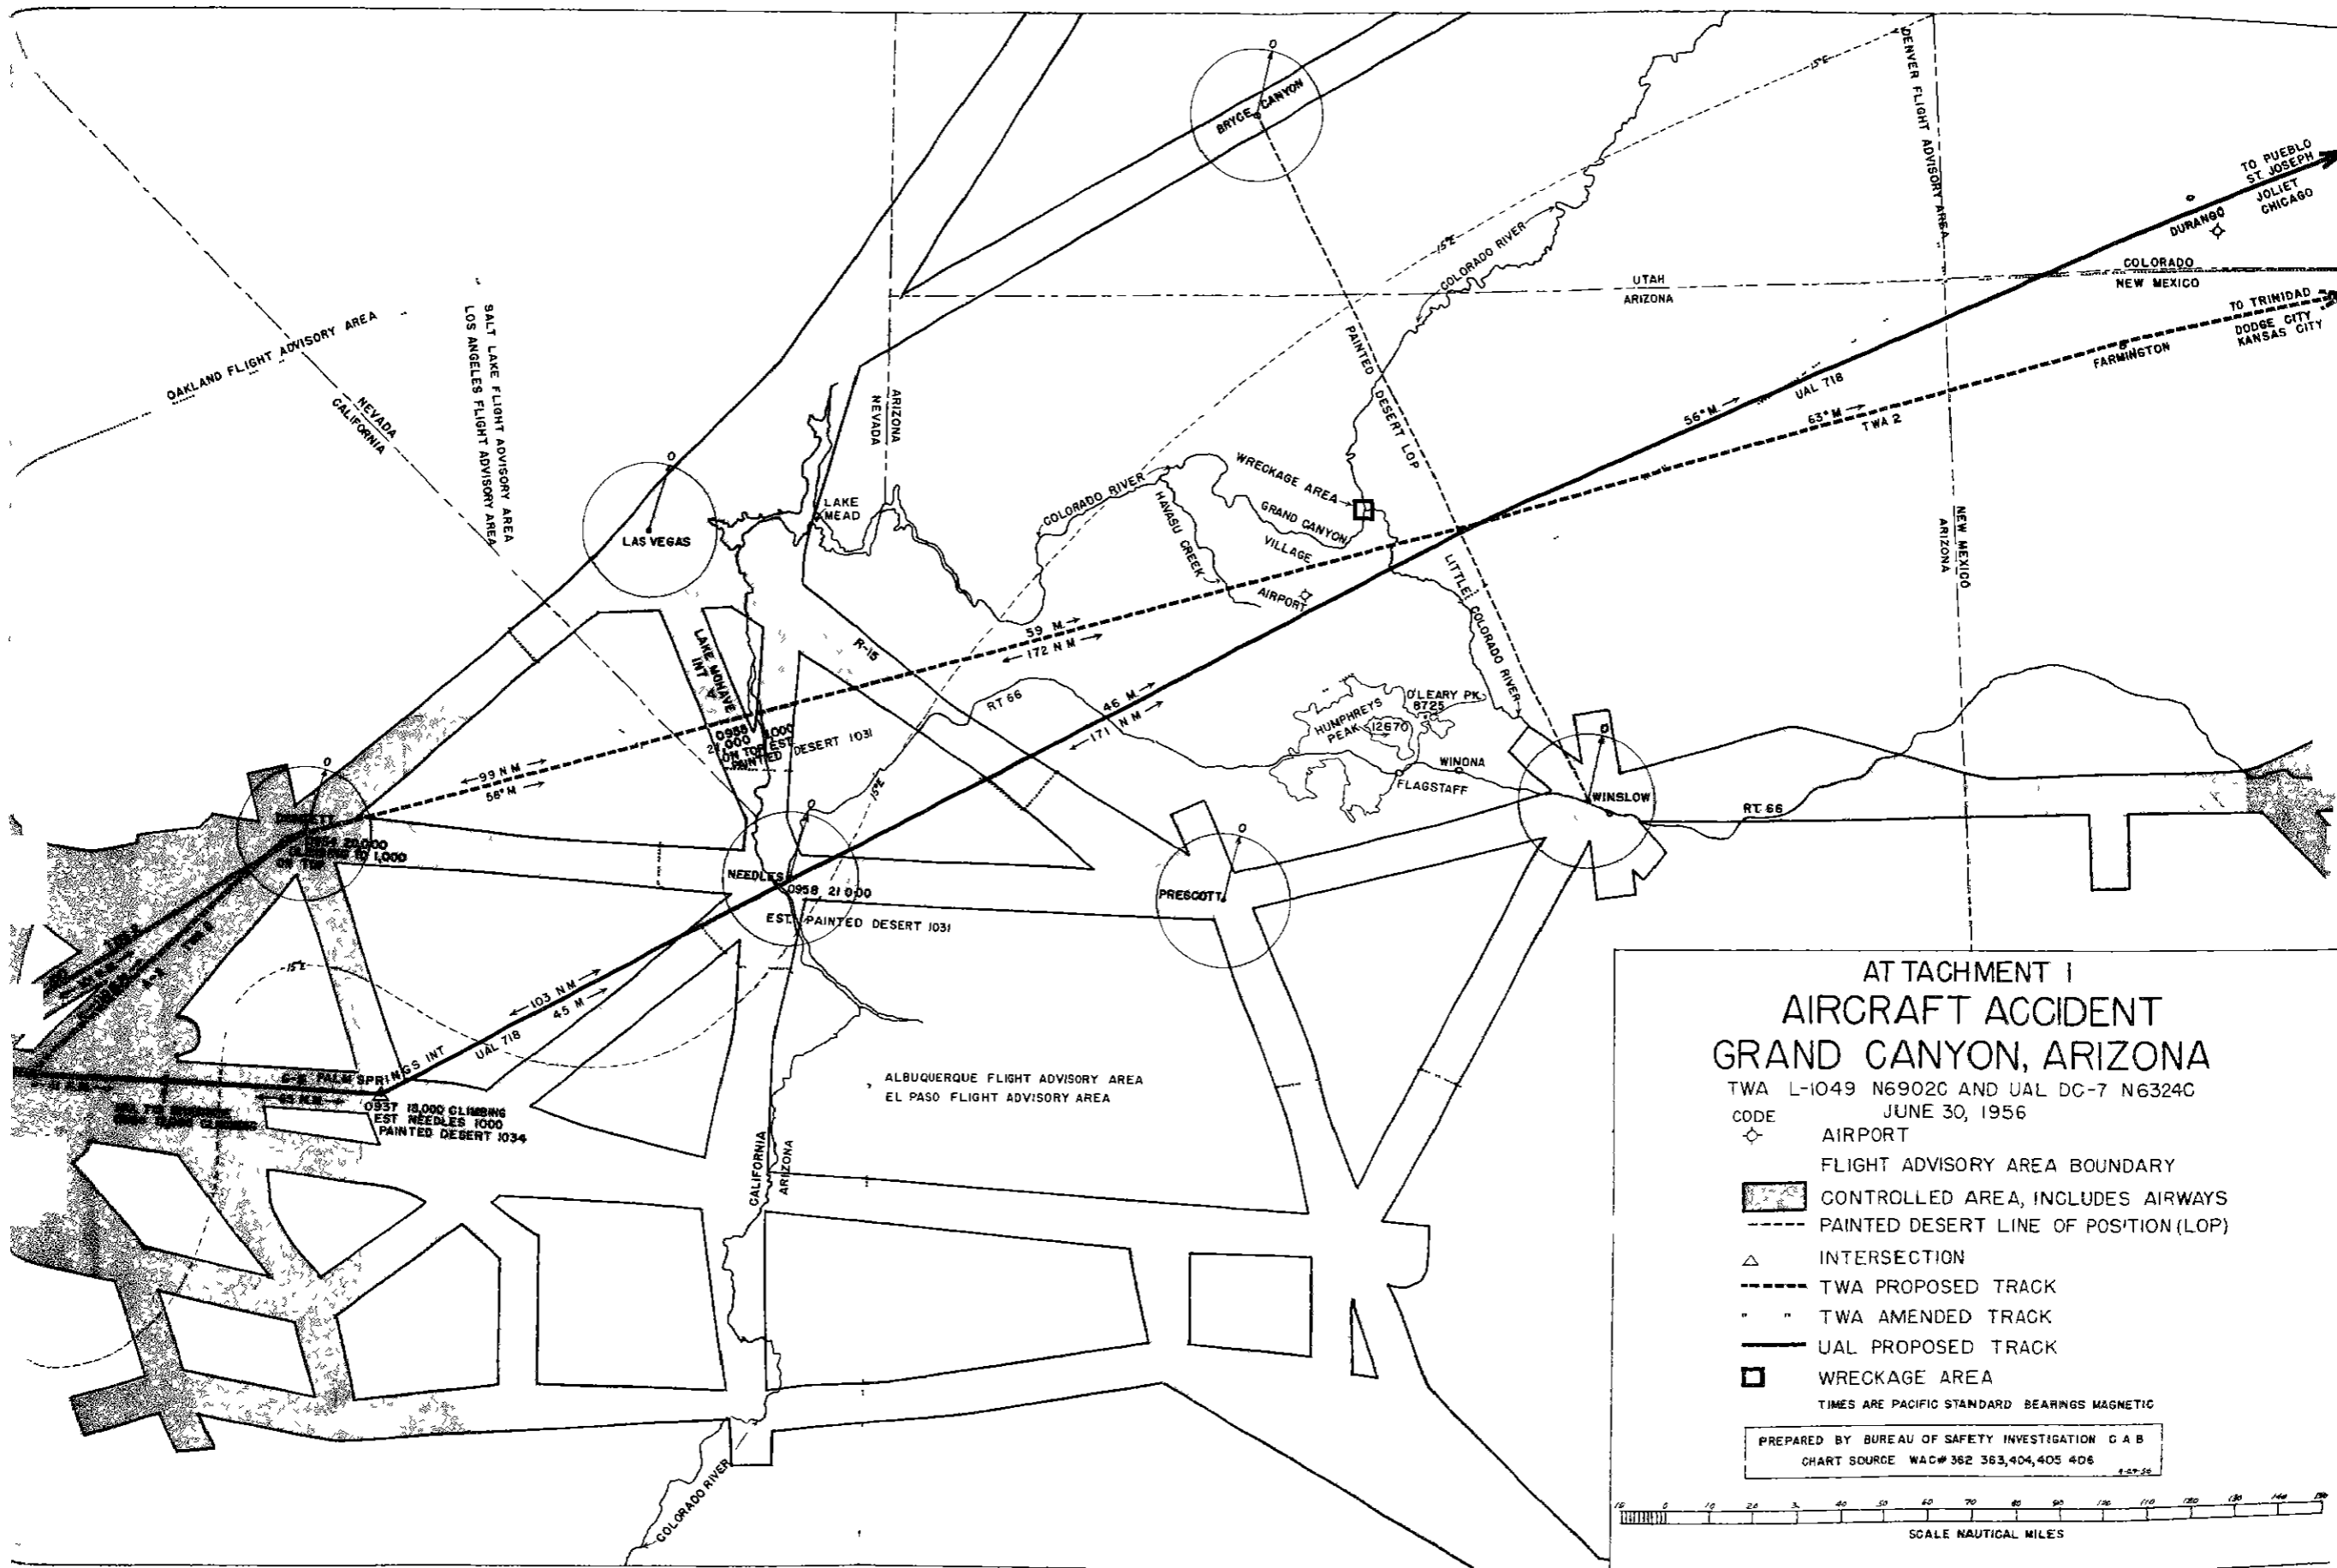
AT TACHMENT I  
 AIRCRAFT ACCIDENT  
 GRAND CANYON, ARIZONA

TWA L-1049 N69020 AND UAL DC-7 N6324C  
 CODE JUNE 30, 1956

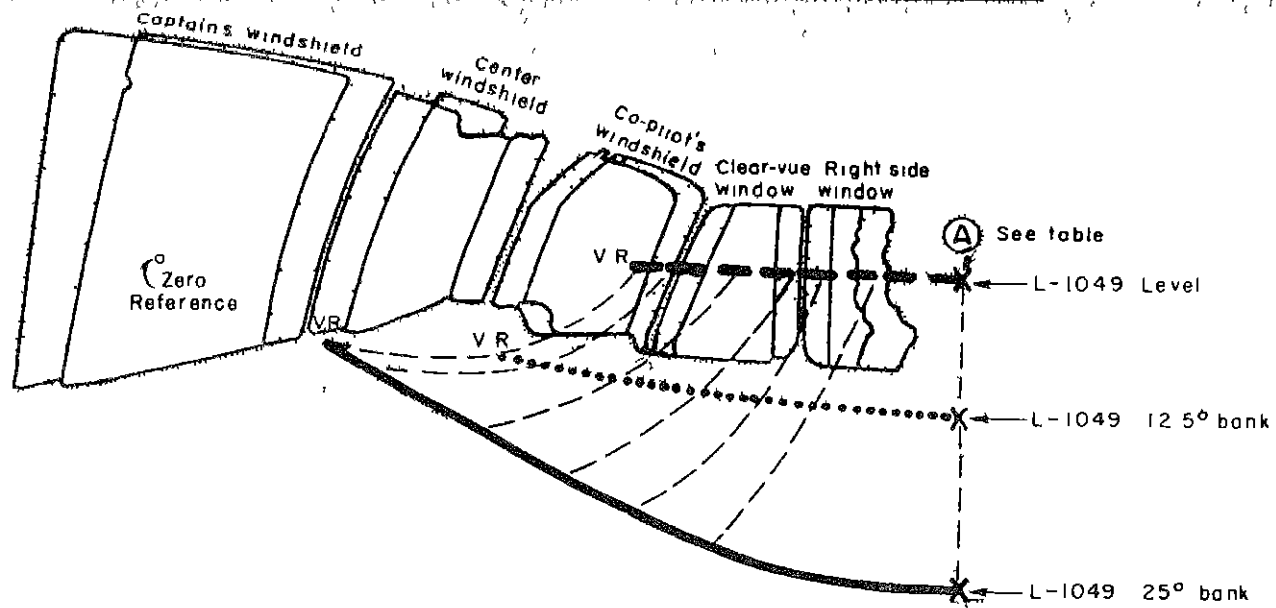
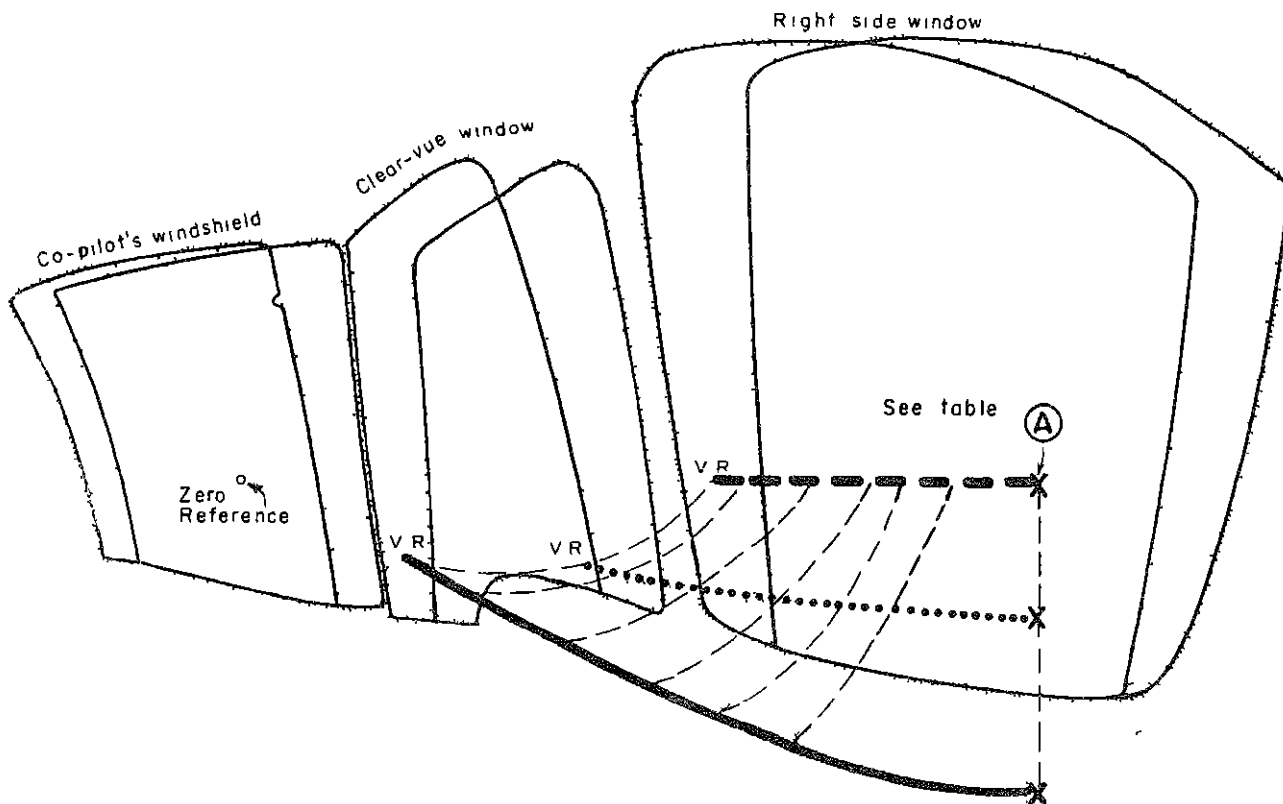
VIEW FROM CO-PILOT'S SEAT

The study indicates that without the intervening cloud condition the DC-7 was within visual range and within the angular limits of cockpit vision from the L-1049 copilot's seat during three of the four flight path situations. Then the time opportunity varied from 50 to 120 seconds, according to the situation. Two of the displays reveal relative motion. Again, in the worst cloud situation his time opportunity was as low as 12 seconds.

Cloud diameter - Miles	-	10	5	2	1	△
Approx time to collision - Seconds	60	50	38	27	21	12
Approx distance between aircraft - Miles	54	48	33	2	15	8
